Manhole Inspection Summary

Manhole # S19I1_031MH

Insp Date: **4/22/08 2:20 PM**

Location Address: **2512 southdene-marbourne ally**

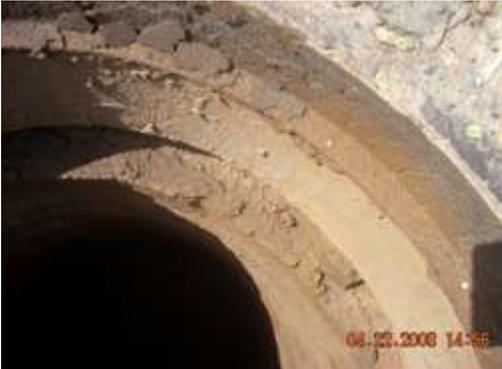
Defect 1

Frame Offset: **2** (in.) Condition: Sound Cracked Leaks

frame offset

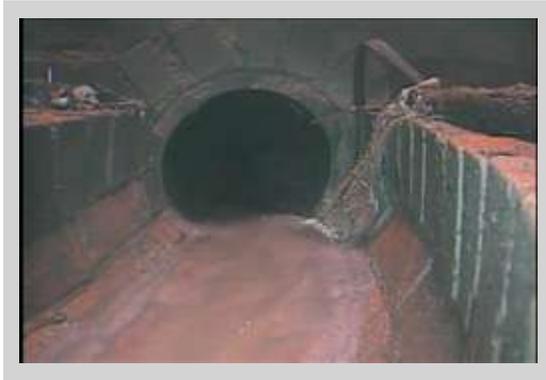
12 O'Clock Outflow

10 in. Circular Gravity Sewer
Pipe Out @ 12 O'Clock

Pipe Height: **10.8** (in.) Rod and Bar (Angled)
Pipe Material: **Clay** Pipe Lined
Invert Depth: **12.84** (ft.) Flow Characteristics: **Fast**
Deposits: None Mud Sludge Debris Grease
Silt Depth: **0** (in.) Deposits Extent:
Infiltration: **None** Pipe Seal Cond: **Sound**

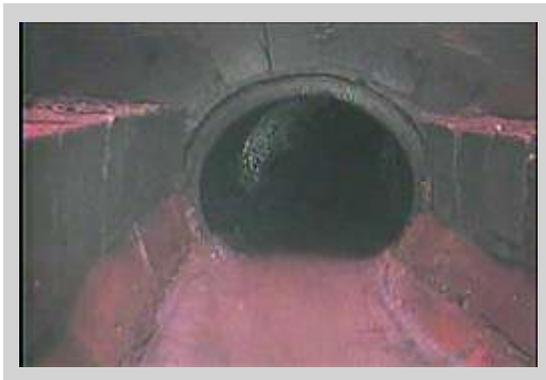
7 O'Clock Inflow

10 in. Circular Gravity Sewer
Pipe In @ 7 O'Clock

Pipe Height: **10.8** (in.) Rod and Bar (Angled)
Pipe Material: **Clay** Pipe Lined
Invert Depth: **12.77** (ft.) Flow Characteristics: **Fast**
Deposits: None Mud Sludge Debris Grease
Silt Depth: **0** (in.) Deposits Extent:
Infiltration: **None** Pipe Seal Cond: **Sound**
